UNDERWATER BRIDGE INSPECTION REPORT

STRUCTURE NO. 96026

MSAS 119

POND OUTLET

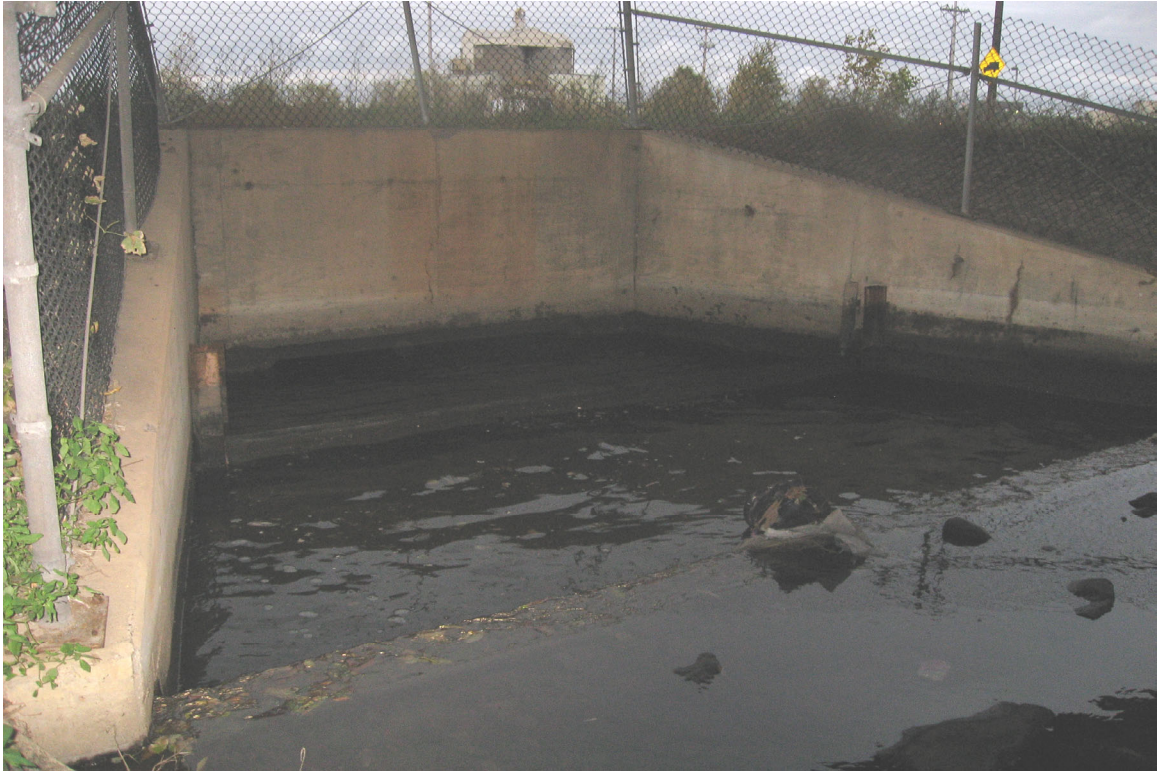
Photograph 1. View of West Opening, Looking Southwest.

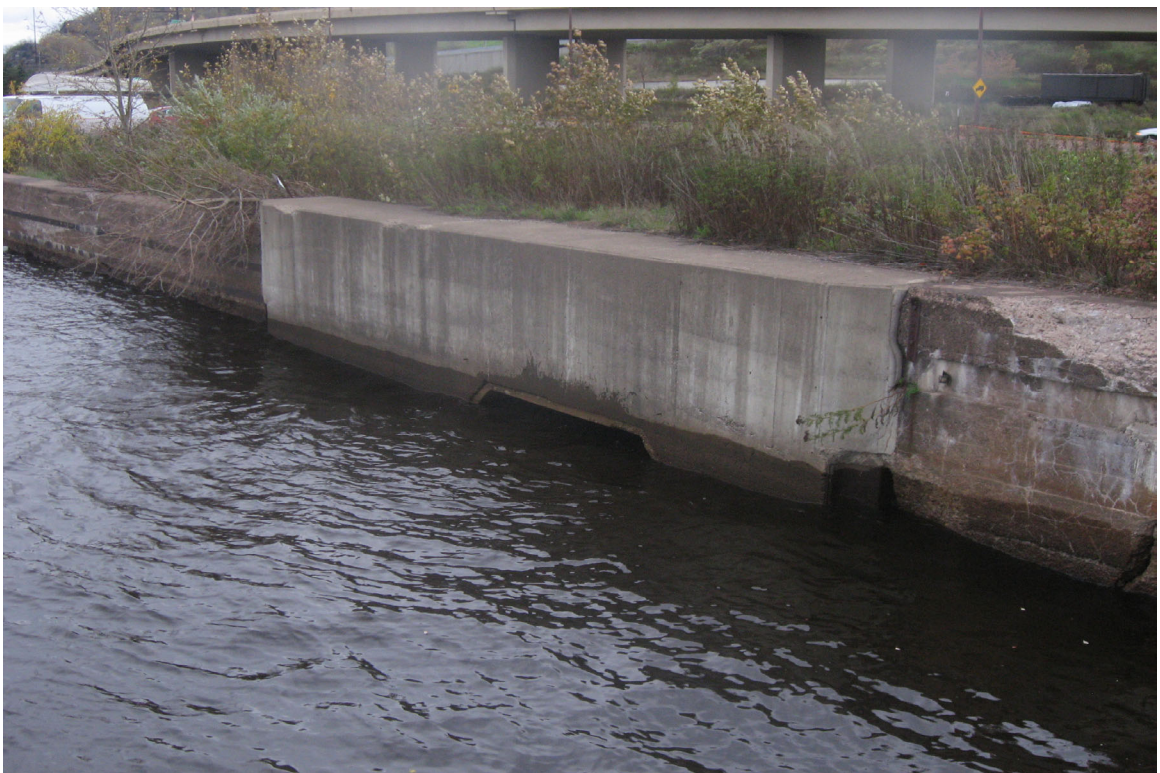
Photograph 2. View of East Opening, Looking West.

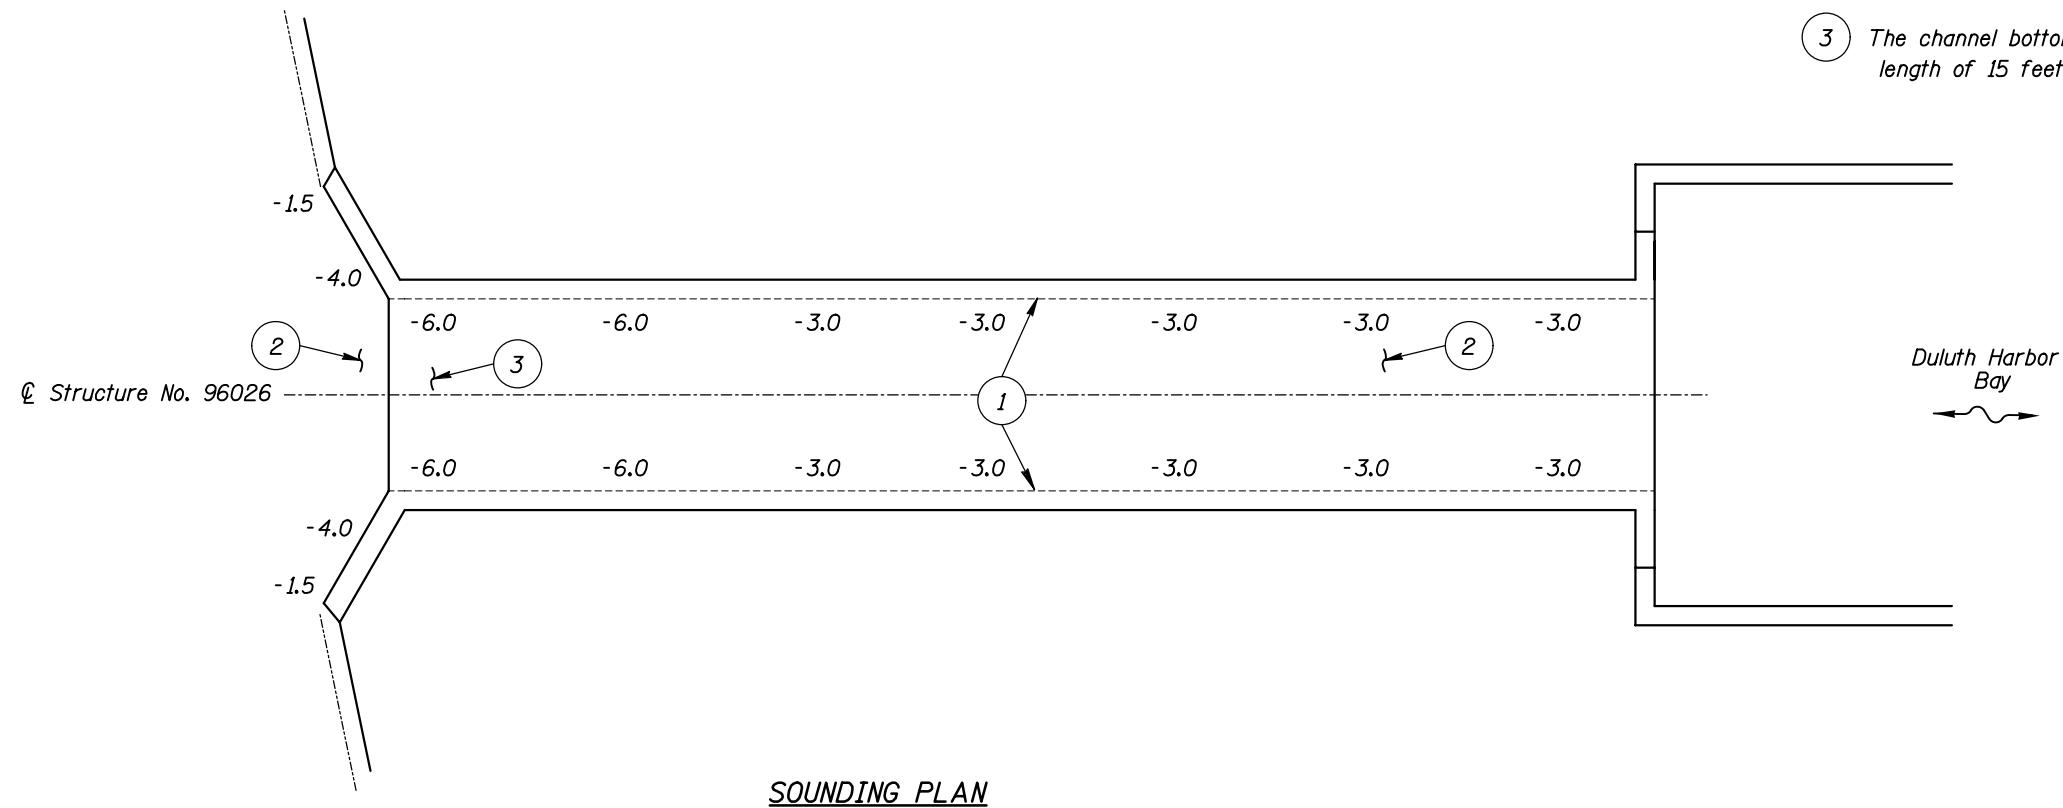
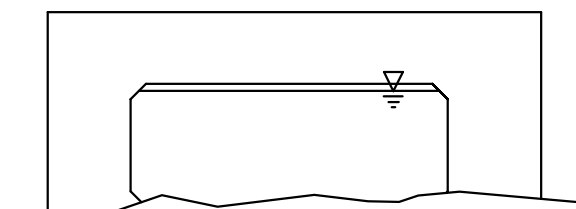
INSPECTION AND SOUNDING PLAN

- 1 The concrete was in smooth and sound condition. The joints between culvert segments exhibited 1/4- to 1-inch-wide horizontal gaps (acceptable for tongue and groove joint arrangement) and up to 1/2-inch differentials across adjacent faces at various joints.
- 2 The channel bottom consisted of sandy infilling (up to 3 feet deep) on culvert floor.
- 3 The channel bottom consisted of riprap with no probe rod penetration for a length of 15 feet along the northwestern end of the box culvert.

SOUTHEASTERN END VIEW OF CULVERT

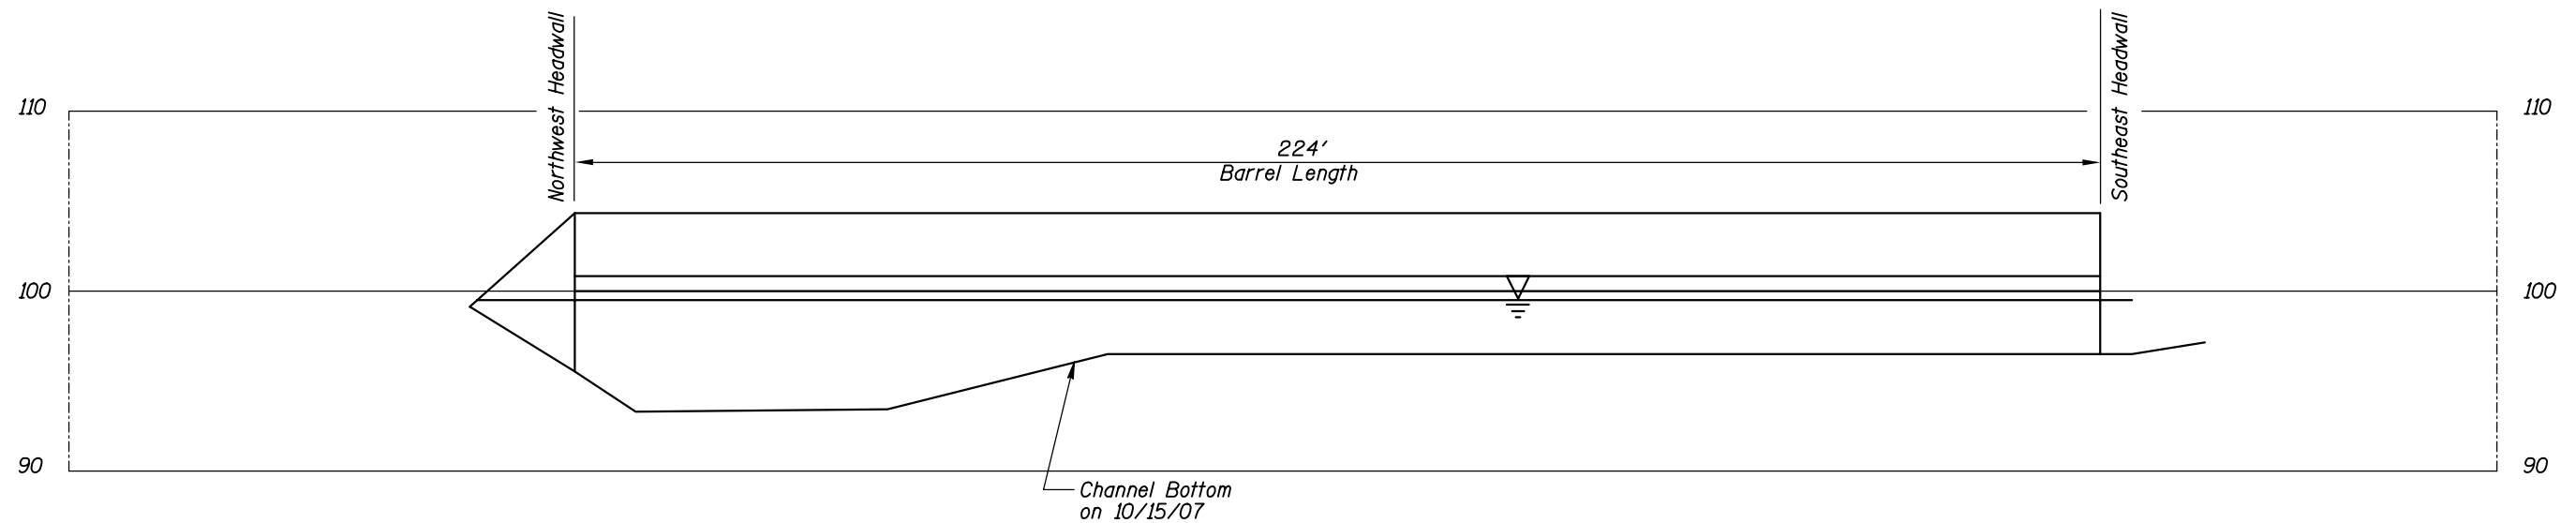
STRUCTURE NO. 96026
OVER STREAM
DISTRICT 1, ST. LOUIS COUNTY
**CENTERLINE ELEVATION
PROFILE**

☺ CULVERT PROFILE
